magicolor[®] 330

Service Manual

November 2000
1750049-001B

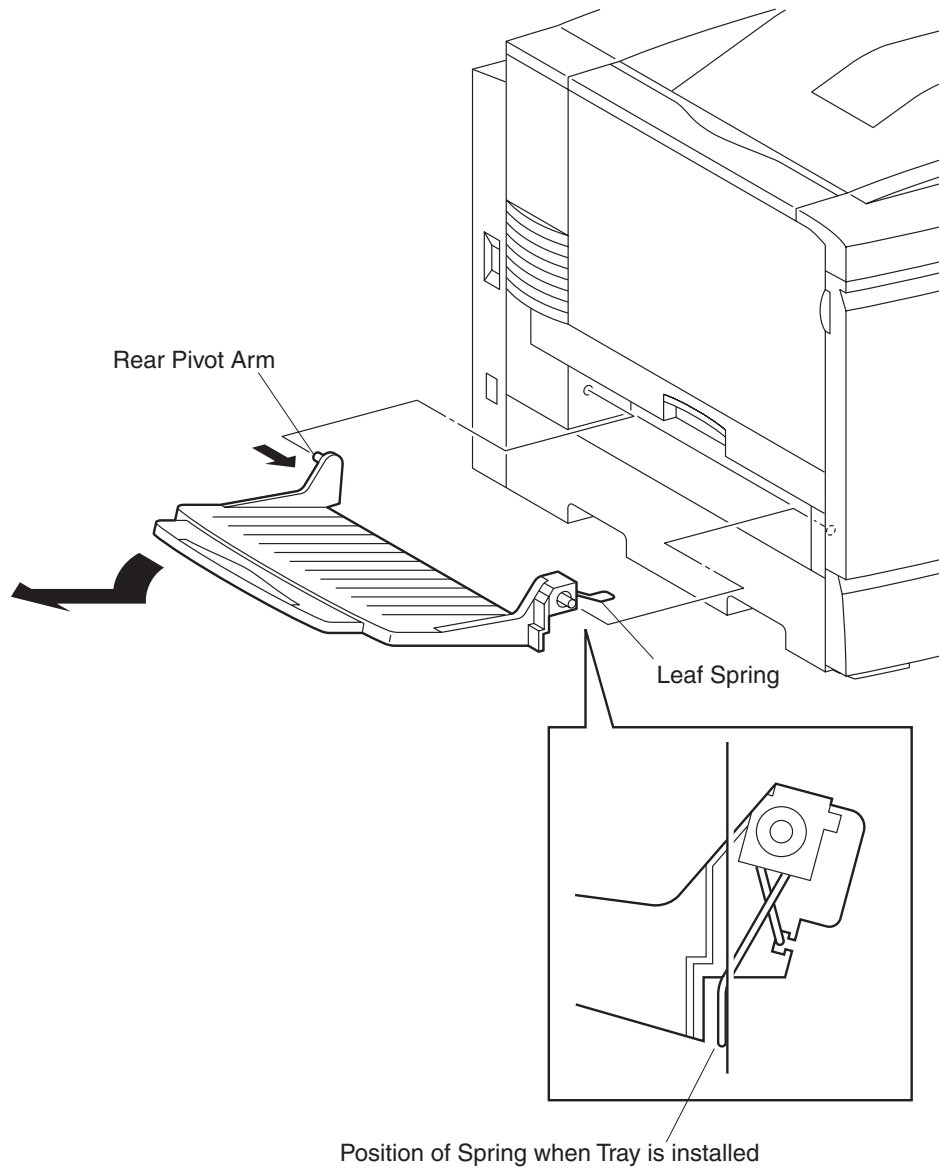
RRP 9.100 Exit Tray (PL10.1.10)

1. Insert the rear pivot arm of the Tray into the rear pivot hole in the printer frame.
2. Pull down on the leaf spring that is located on the front pivot arm and insert the front arm into the front pivot hole, making sure the spring rests against the printer frame and is not inside the pivot hole.
3. Open and close the Exit Tray to make sure it moves smoothly.

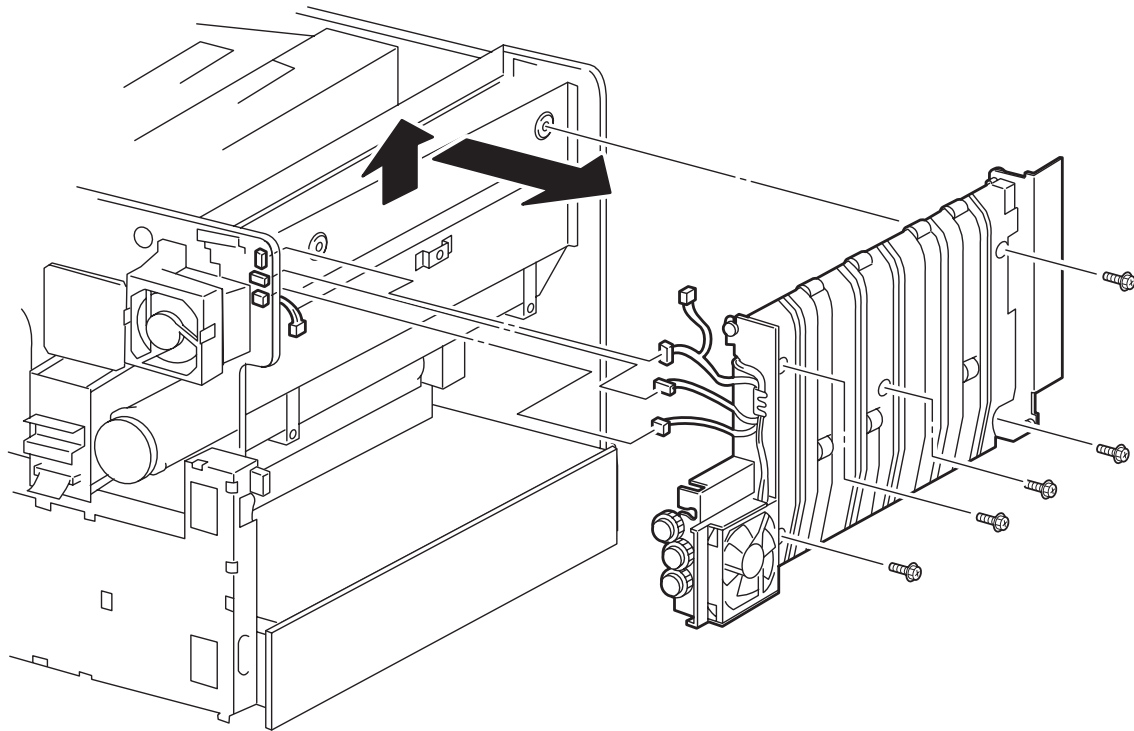
RRP 9.101 Lower Exit Assembly (PL10.1.1)

1. Reconnect P/J 165 to the Top Exit Sensor and P/J 166 to the Exit Chute Switch.
2. Route the wire harnesses through the groove in the top rear of the Lower Exit Assembly.
3. Hook the top of the Lower Exit Assembly onto the top of the printer frame and position the Assembly so the five screw holes in the Assembly line up with the five screw holes in the printer frame.
4. Use five screws to secure the Lower Exit Assembly to the printer frame.
5. Reconnect P/J 111 to the P/J near the top rear of the Lower Exit Assembly.
6. Reconnect P/J 161 to the P/J near the top rear of the Lower Exit Assembly.
7. Reinstall the wires under the wire clips that are molded into the side of the Lower Exit Assembly.
8. Reinstall the Upper Exit Assembly (RRP 9.102).

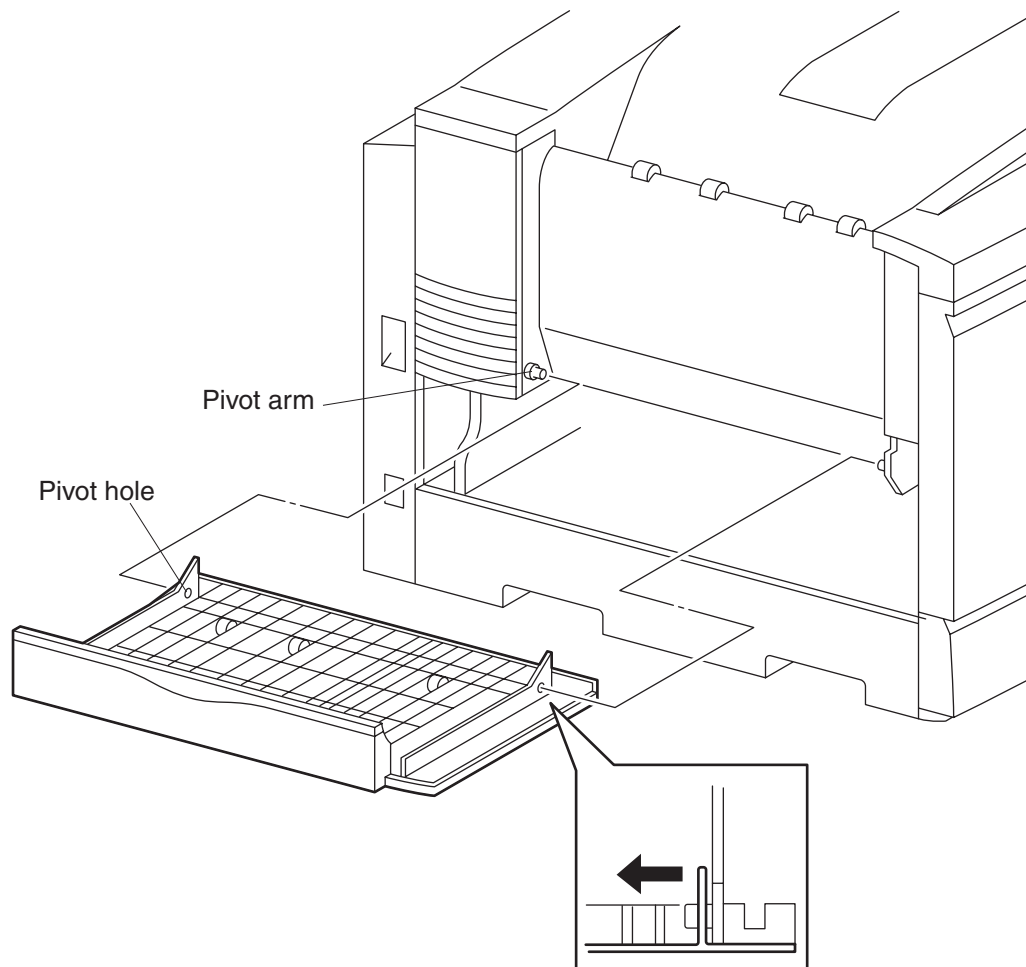
RRP 9.102 Upper Exit Assembly (PL10.1.2)

1. Position the Upper Exit Assembly at about a 45° angle to the printer frame.
2. Insert the front pivot hole of the Upper Exit Assembly into the front pivot arm of the Lower Exit Assembly.
3. Push in the on the rear of the Upper Exit Assembly enough so the rear pivot arm of the Lower Exit Assembly fits into the rear pivot hole of the Upper Exit Assembly.
4. Open and close the Upper Exit Assembly to make sure it moves smoothly.

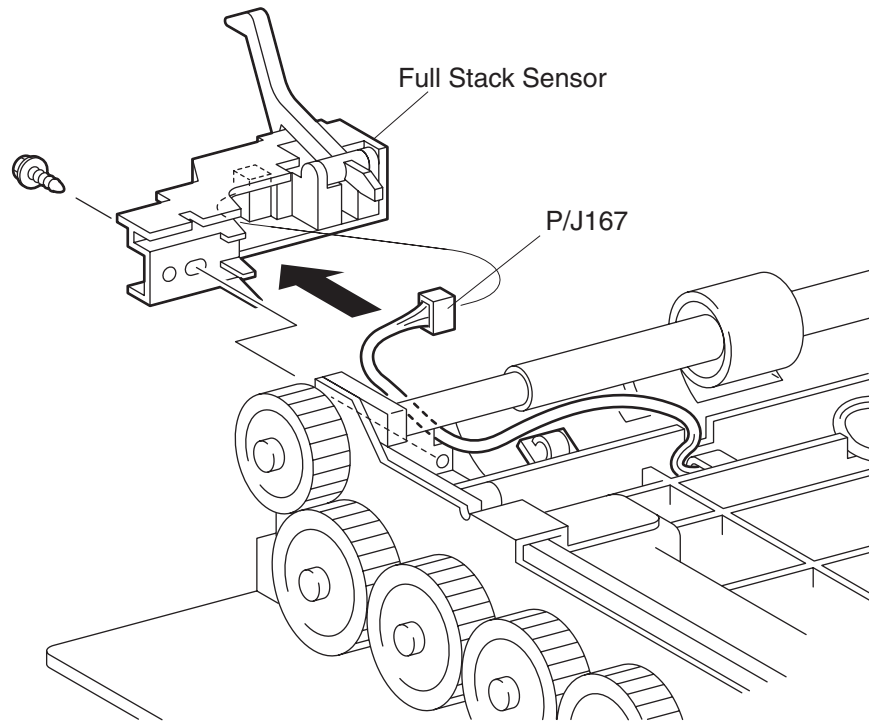
RRP 9.103 Full Stack Sensor (PL10.2.21)

1. Reconnect P/J167 to the Full Stack Sensor.
2. Route the Full Stack Sensor wire harness through the wire clamp.
3. Reinstall the Full Stack Sensor onto the Lower Exit Assembly and use one screw to secure the Sensor.
4. Reinstall the Lower Exit Assembly (RRP 9.101).

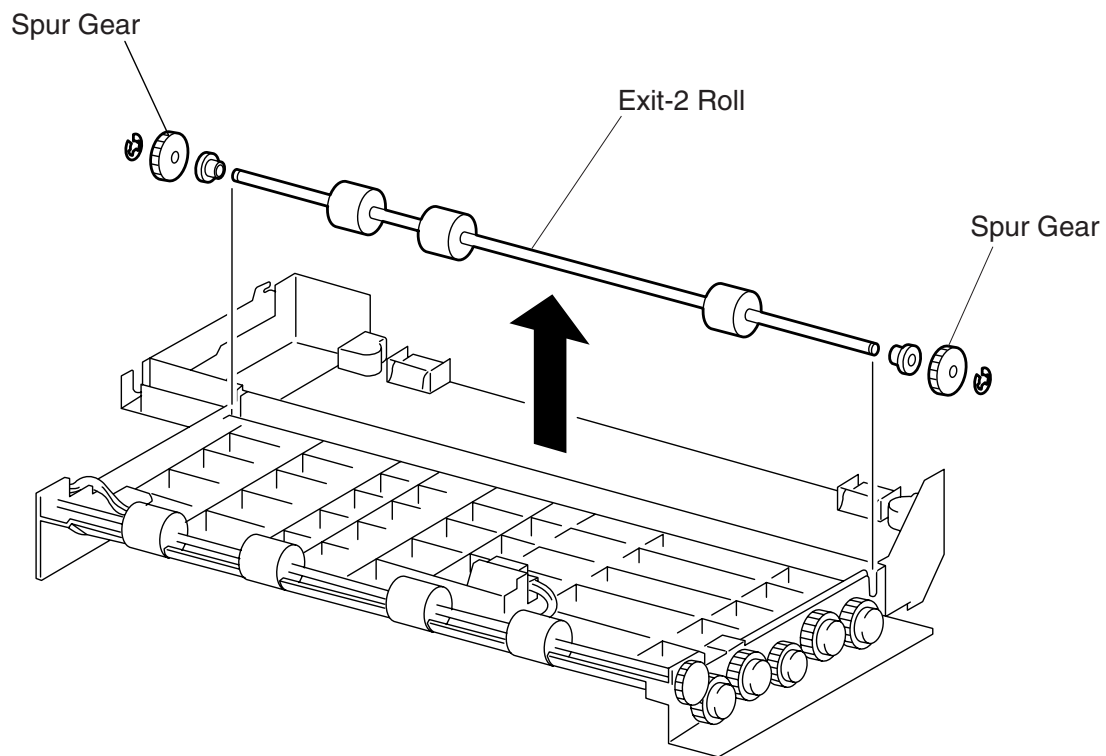
RRP 9.104 Exit-2 Roll Assembly (PL10.2.5)

1. Position the Exit-2 Roll Assembly so the three rubber rollers line up with the indentations in the slot in the Lower Exit Assembly.
2. Reinstall the Exit-2 Roll Assembly into the slot in the Lower Exit Assembly.
3. Slide the Front and Rear Bearings onto the Exit-2 Roll Shaft and push the Bearings into the notches in the Lower Exit Assembly.
4. Slide a Spur Gear onto the front of the Exit-2 Roll Shaft and use an E ring to secure the Gear to the Shaft.
5. Slide a Spur Gear onto the rear of the Exit-2 Roll Shaft and use an E ring to secure the Gear to the Shaft.
6. Reinstall the Lower Exit Assembly (RRP 9.101).

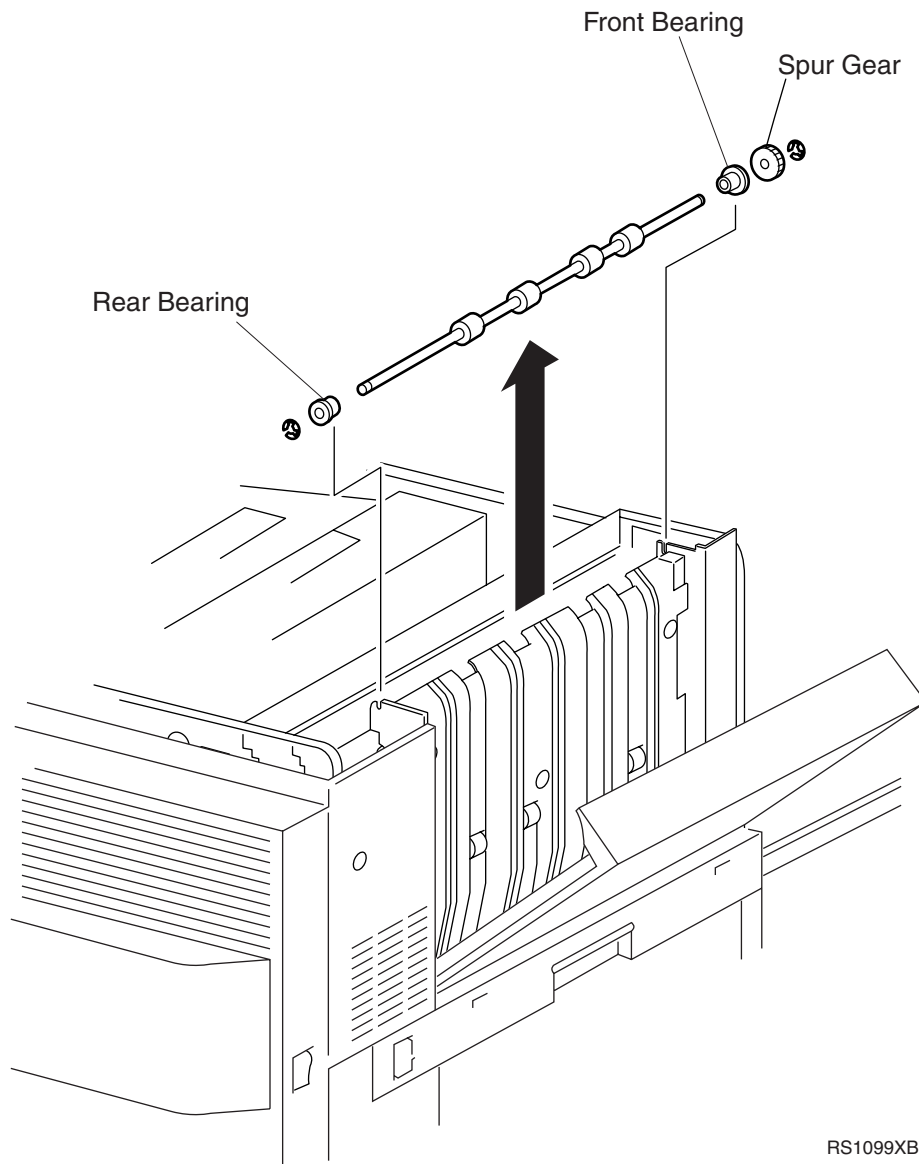
RRP 9.105 Exit-3 Roll Assembly (PL10.2.7)

1. Position the Exit-3 Roll Assembly so the four rubber rollers line up with the indentations in the Lower Exit Assembly.
2. Reinstall the Exit-3 Roll Assembly into the slot in the Lower Exit Assembly.
3. Slide the Front and Rear Bearings onto the Exit-3 Roll Shaft and push the Bearings into the notches in the Lower Exit Assembly.
4. Slide a Spur Gear onto the front of the Exit-3 Roll Shaft and use an E ring to secure the Gear to the Shaft.
5. Use an E ring to secure the Exit-3 Roll Shaft to the front of the Lower Exit Assembly.
6. Reinstall the Top Cover (RRP 9.3).

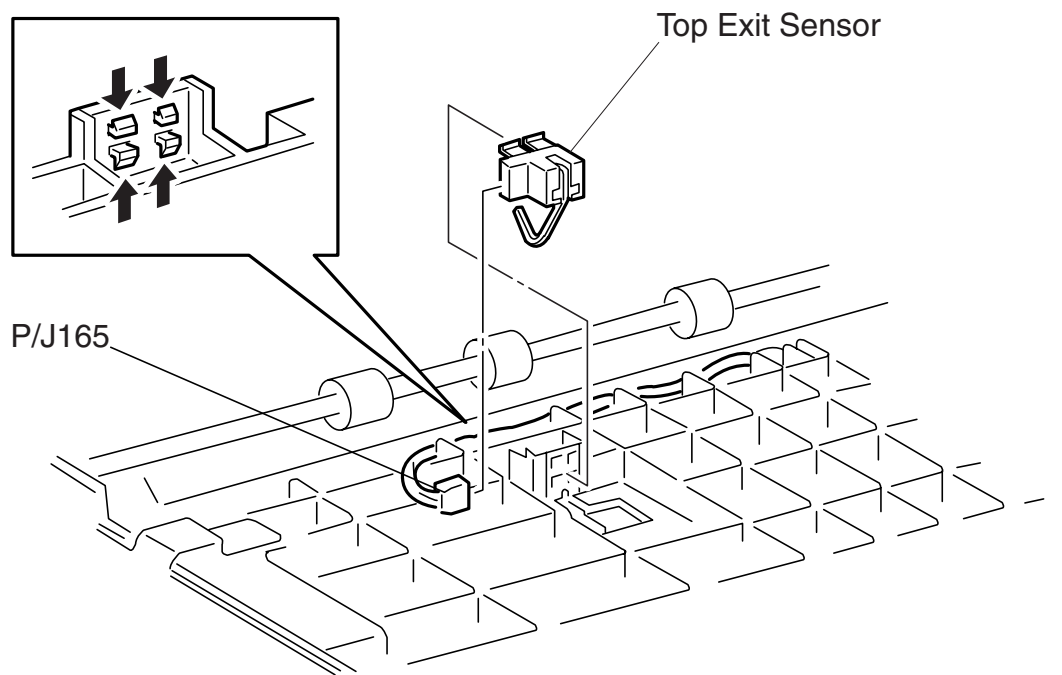
RRP 9.106 Top Exit Sensor (PL10.2.12)

1. Slide the Top Exit Sensor Actuator through the slot in the Assembly.
2. Press the Sensor against the Lower Exit Assembly until the latches snap into place.
3. Make sure the Actuator moves freely.
4. Reinstall the Lower Exit Assembly (RRP 9.101).

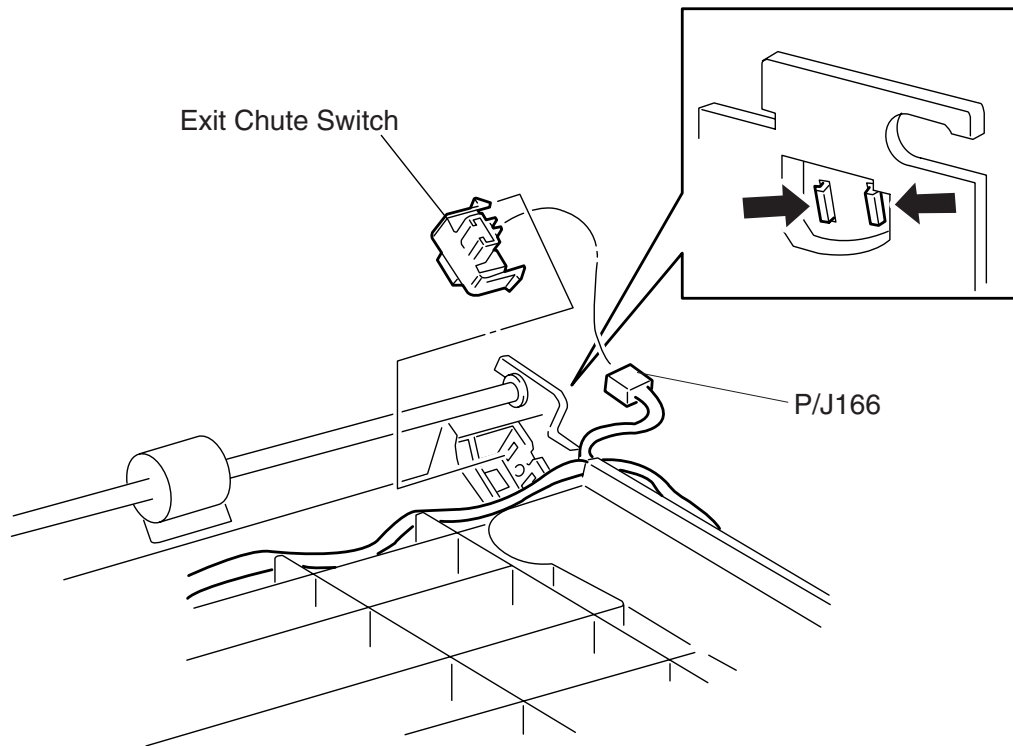
RRP 9.107 Exit Chute Switch (PL10.2.13)

1. Position the Exit Chute Switch against the Lower Exit Assembly.
2. Line up the positioning pin and the two latches on the Sensor with the three holes in the Lower Exit Assembly.
3. Press the Sensor against the Assembly until the latches snap into place.
4. Reinstall the Lower Exit Assembly (RRP 9.101).

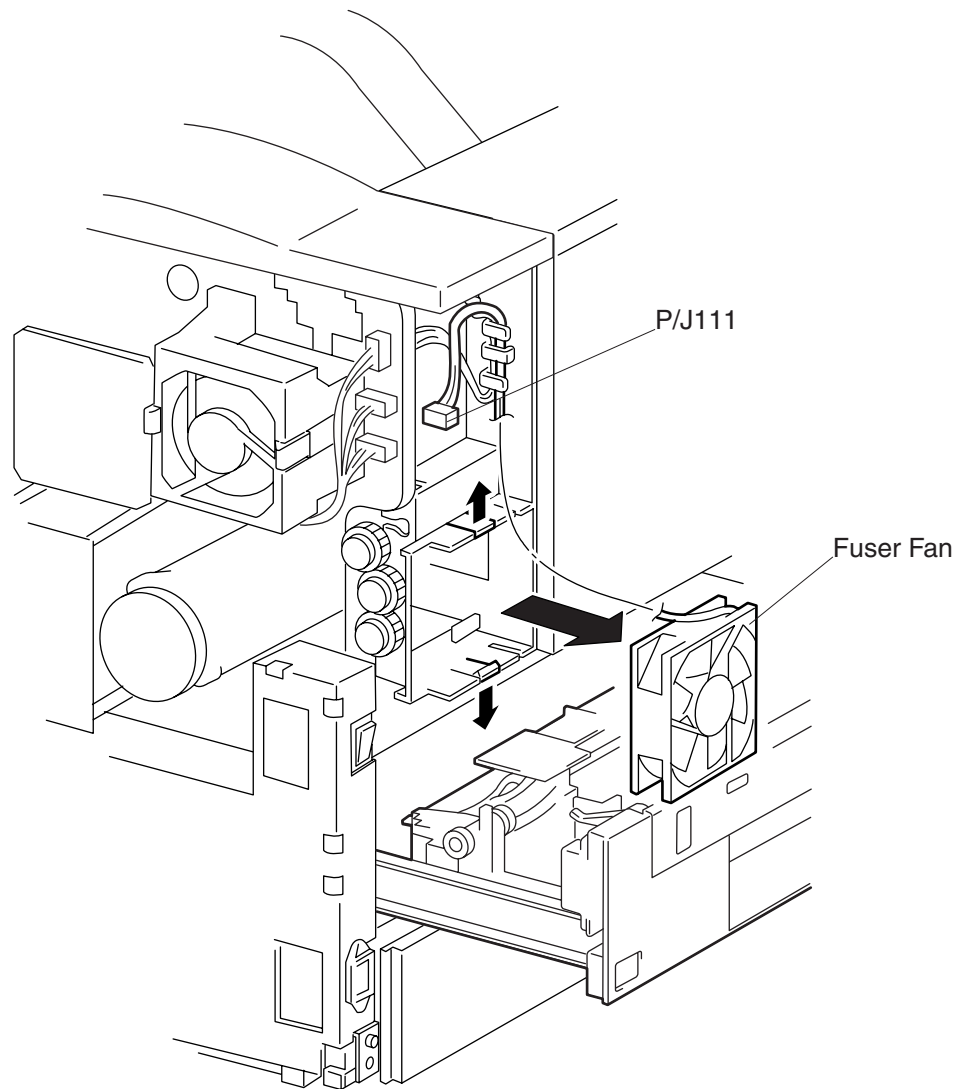
RRP 9.108 Fuser Fan (PL10.2.15)

1. Position the Fuser Fan so the label faces out and the wires exit the Fan at the top right.
2. Spread the two latches on the Lower Exit Assembly and push the Fuser Fan into the Assembly.
The latches lock the Fan into place in the Lower Exit Assembly.
3. Reconnect P/J 111 to the P/J near the top rear of the Lower Exit Assembly.
4. Reinstall the Rear Cover (RRP 9.4).

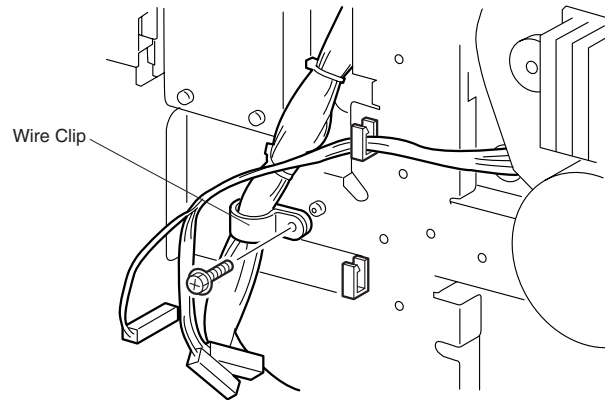
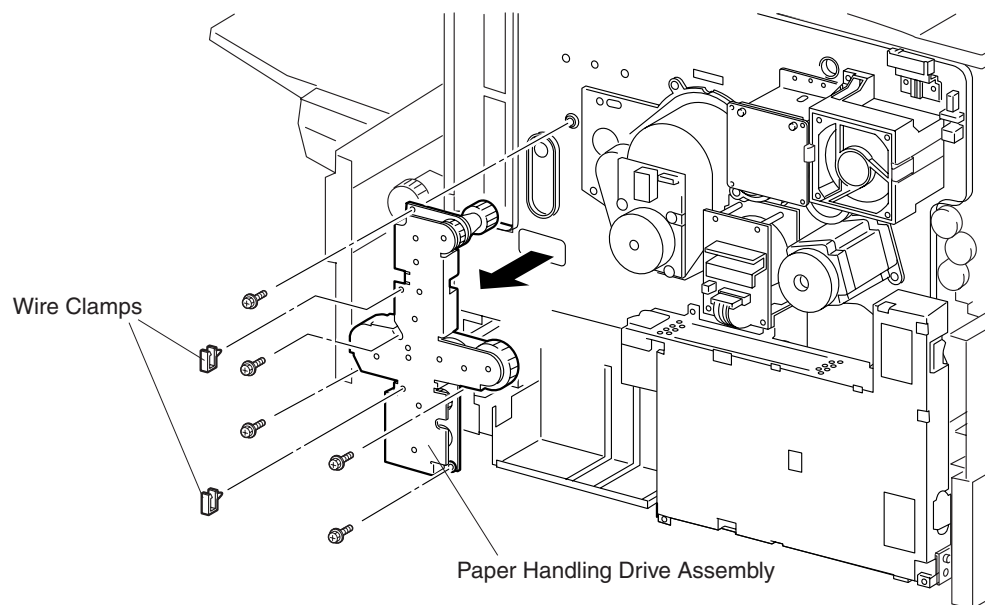
RRP 9.109 Paper Handling Drive Assembly (PL11.1.1)

1. Reinstall the two wire clamps onto the Paper Handling Drive Assembly.
2. Position the Paper Handling Drive Assembly against the printer frame so the single gear fits through the cutout at the top of the frame.
3. Press the Paper Handling Drive Assembly against the printer frame so all of the gears fit through the cutouts and the five screw holes in the Assembly line up with the five screw holes in the frame.
4. Use five screws to secure the Paper Handling Drive Assembly to the printer frame.
5. Reinstall the wire clip and attached wire harness to the Paper Handling Drive Assembly and use one screw to secure the clip to the Assembly.
6. Slide the Main Paper Handling Assembly into the printer.
7. Reinstall the High Voltage Power Supply (RRP 9.120).

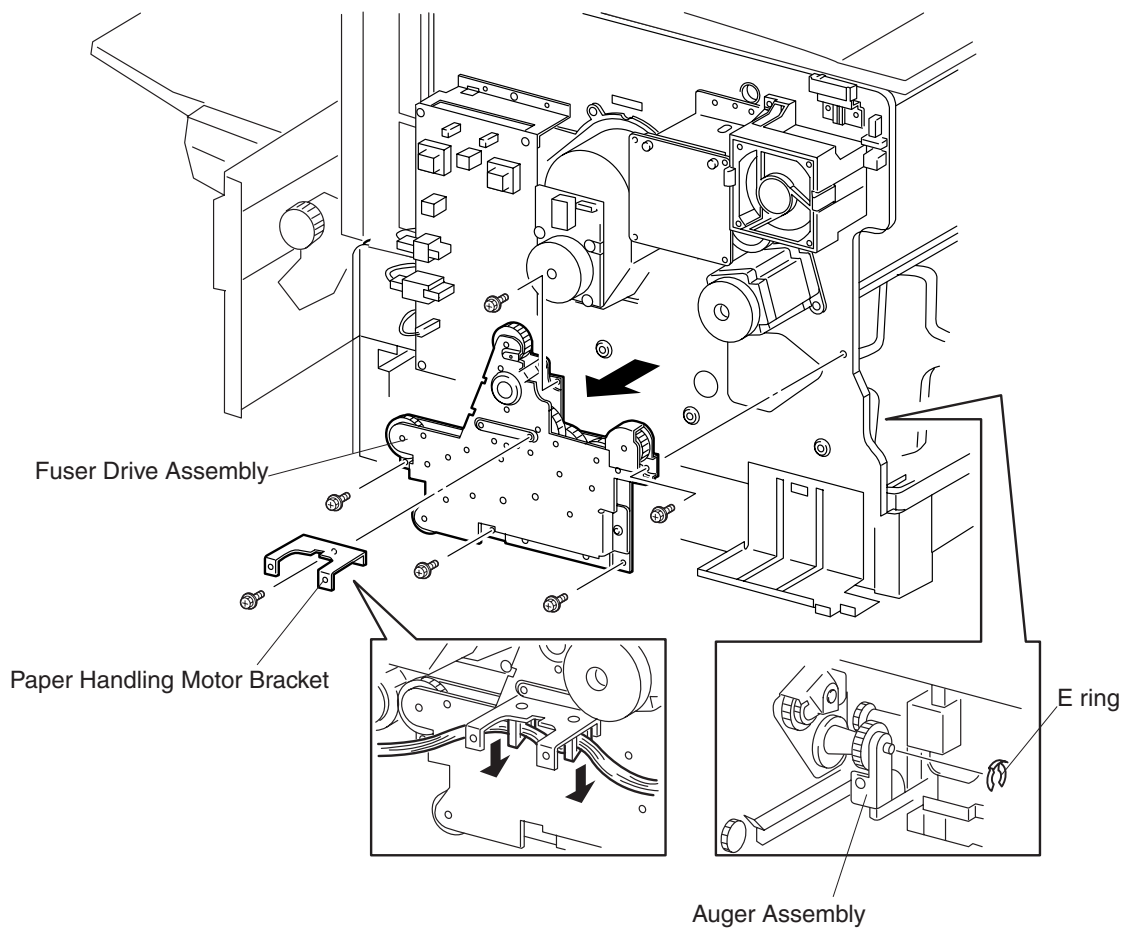
RRP 9.110 Fuser Drive Assembly (PL11.1.2)

1. Reinstall the Fuser Drive Assembly onto the printer frame by inserting the Drive Gears into the cutout in the printer frame, and inserting the Fuser Drive Gear shaft into the hole in the Auger Drive Assembly.
2. Line up the five screw holes in the Fuser Drive Assembly with the five screw holes in the printer frame and use five screws to secure the Fuser Drive Assembly to the frame.
3. Reach inside the empty Fuser Assembly cavity and reinstall the E ring securing the Fuser Drive Gear shaft to the Auger Drive Assembly.
4. Reinstall the Paper Handling Motor Bracket onto the Fuser Drive Assembly and use one screw to secure the Bracket to the Assembly.
5. Reinstall the wire harness under the Paper Handling Motor Bracket.
6. Reinstall the Paper Handling Motor Assembly (RRP 9.111).
7. Reinstall the Low Voltage Power Supply (RRP 9.119).
8. Reinstall the Fuser Assembly (RRP 9.80).

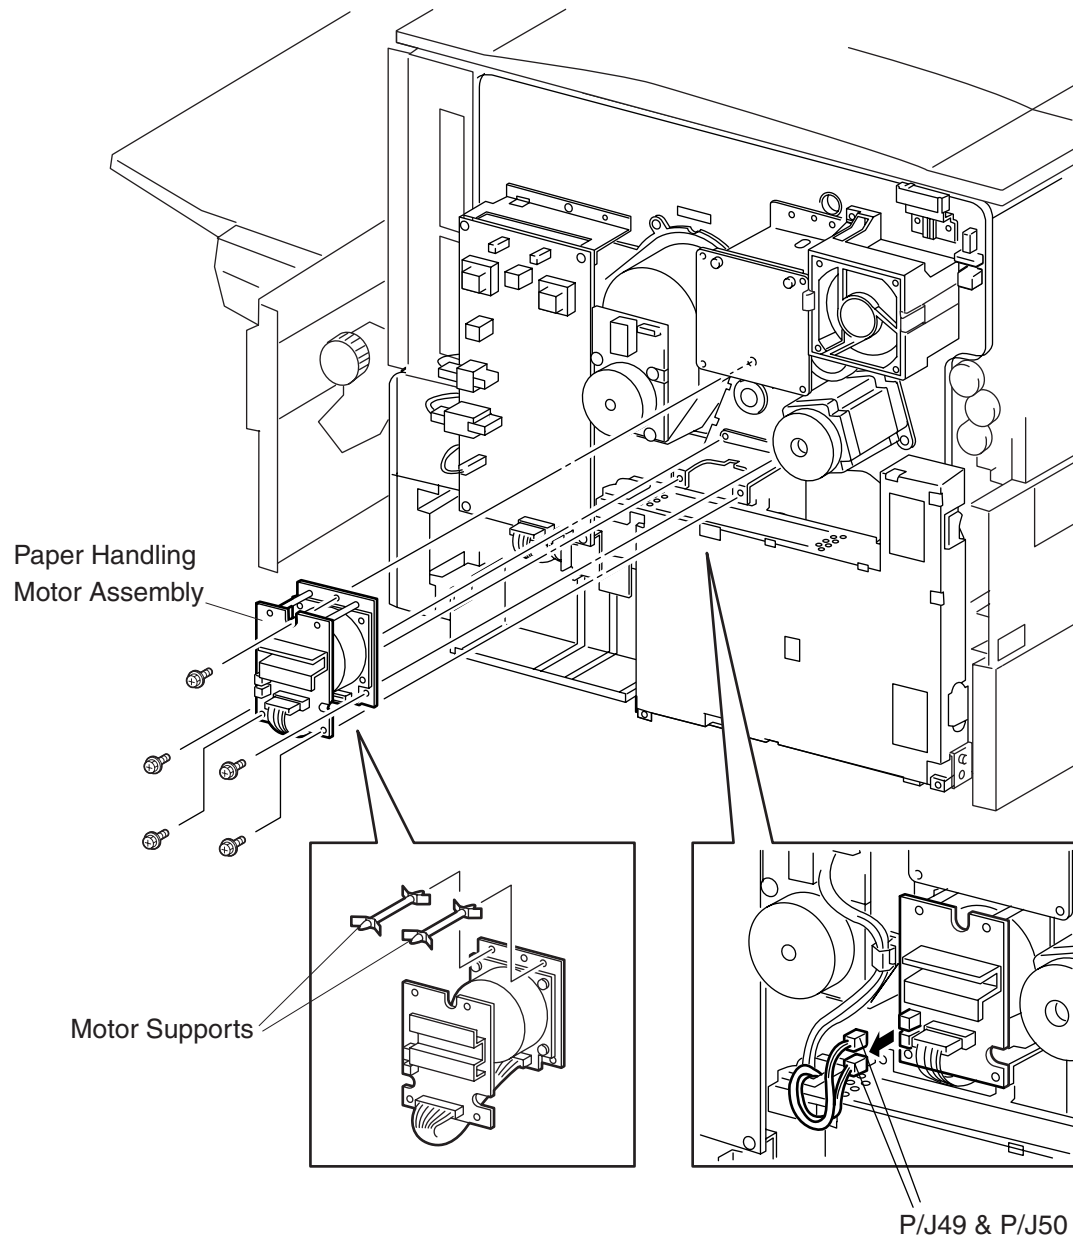
RRP 9.111 Paper Handling Motor Assembly (PL11.1.3)

1. Reinstall the two Motor Supports between the Motor and the Motor PWB.
2. Reinstall the Paper Handling Motor Assembly onto the Fuser Drive Assembly by inserting the motor shaft into the cutout in the Fuser Drive Assembly.
3. Line up the five screw holes in the Motor Assembly with the four screw holes in the Fuser Drive Assembly.
4. Use four screws to secure the Paper Handling Motor Assembly to the Fuser Drive Assembly.
5. Reconnect P/J 49 and P/J 50 to the Paper Handling Motor PWB.
6. Reinstall the Rear Cover (RRP 9.4).

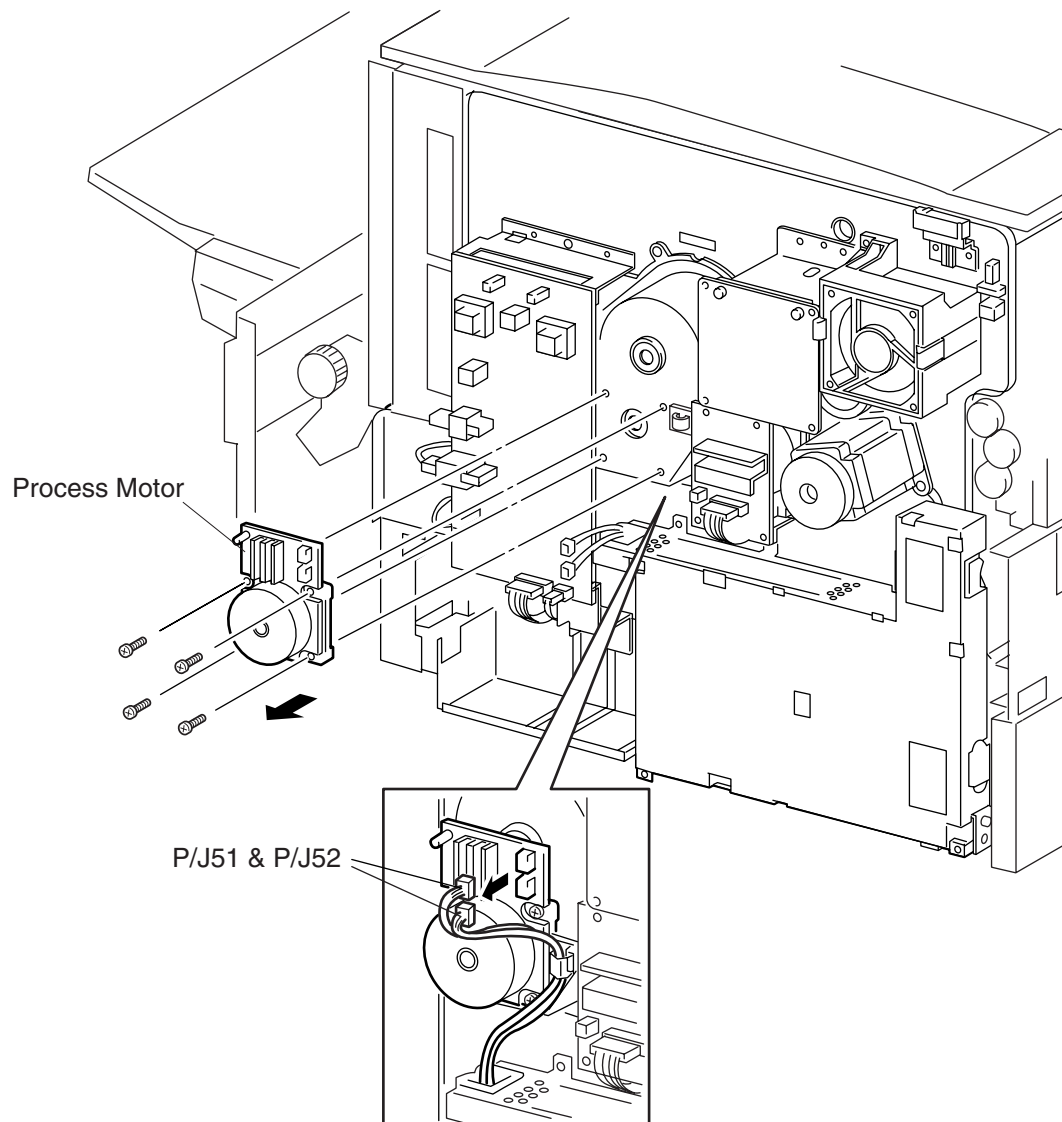
RRP 9.112 Process Motor Assembly (PL11.1.12)

1. Reinstall the Process Motor Assembly onto the Process Drive Assembly.
2. Line up the four screw holes in the Motor Assembly with the four screw holes in the Process Drive Assembly.
3. Use four screws to secure the Motor Assembly to the Drive Assembly.
4. Reconnect P/J 51 and P/J 52 to the Process Motor PWB.
5. Reinstall the Rear Cover (RRP 9.4).

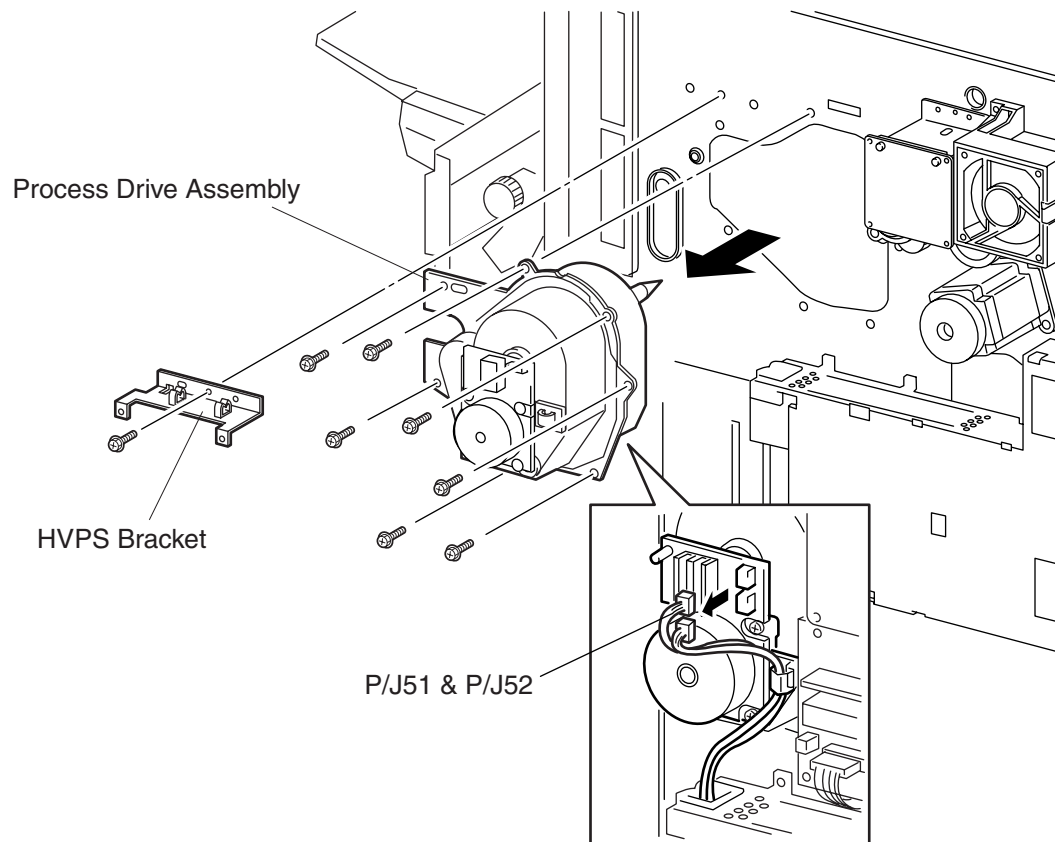
RRP 9.113 Process Drive Assembly (PL11.1.10)

1. Reinstall the Process Drive Assembly onto the printer frame, making sure you line up the positioning slot at the top left side of the Assembly with the positioning pin on the printer frame.
2. Use seven screws to secure the Process Drive Assembly to the printer frame.
3. Reinstall the HVPS Bracket to the printer frame and use one screw to secure the Bracket.
4. Reconnect P/J 51 and P/J 52 leading to the Process Motor PWB and hook the wires under the wire harness clip that is attached to the Process Drive Assembly.
5. Reinstall the Paper Handling Drive Assembly (RRP 9.109).
6. Reinstall the Xerographic Cartridge (RRP 9.48).

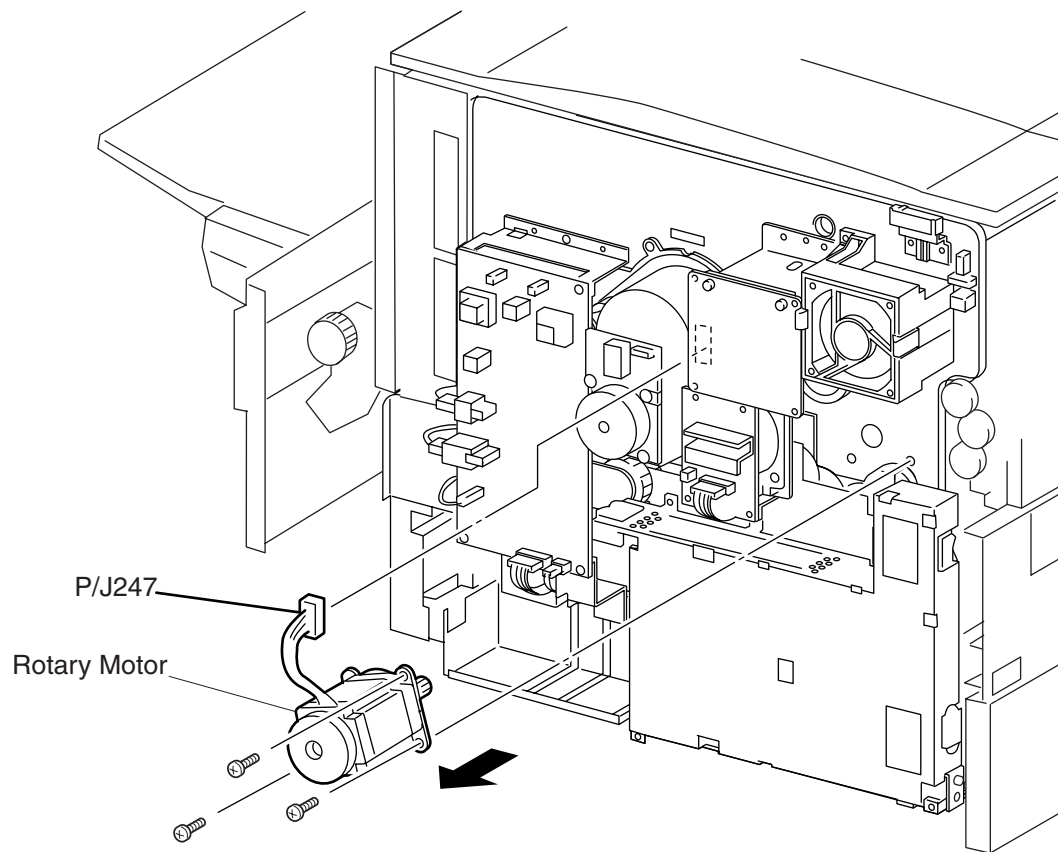
RRP 9.114 Rotary Motor Assembly (PL11.1.20)

1. Position the Rotary Motor Assembly so the wires are at the top.
2. Reinstall the Rotary Motor Assembly onto the printer frame, repositioning the Motor so the two positioning tabs on the Motor fit into the two positioning holes in the frame.
3. Use three screws, top right, bottom right, and bottom left, to secure the Rotary Motor Assembly to the printer frame.
4. Reconnect P/J 247 to the Rotary Motor PWB.
5. Reinstall the Rear Cover (RRP 9.4).

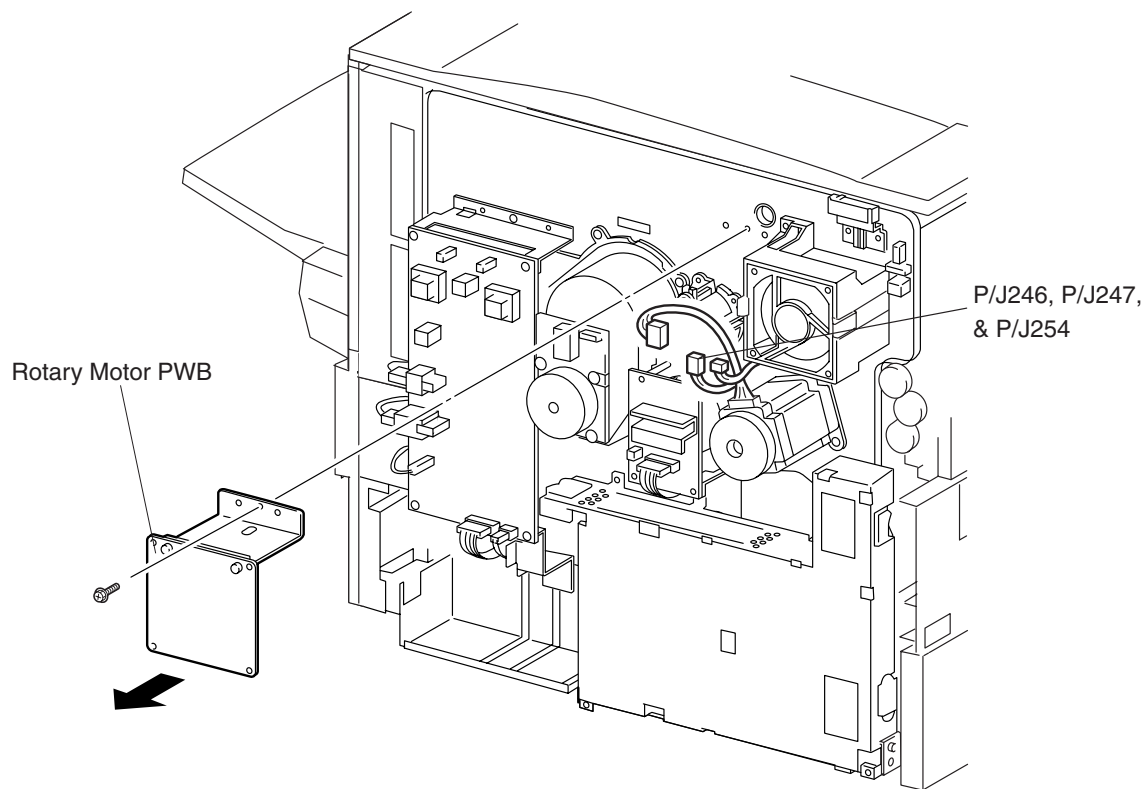
RRP 9.115 Rotary Motor PWB (PL11.1.21)

1. Reinstall the Rotary Motor PWB onto the printer frame.
2. Reposition the PWB so the two positioning holes and the screw hole in the PWB line up with the two positioning tabs and screw hole in the printer frame.
3. Use one screw to secure the Rotary Motor PWB to the printer frame.
4. Reconnect P/J 246, P/J 247, and P/J 254 to the Rotary Motor PWB.
5. Reinstall the Rear Cover (RRP 9.4).

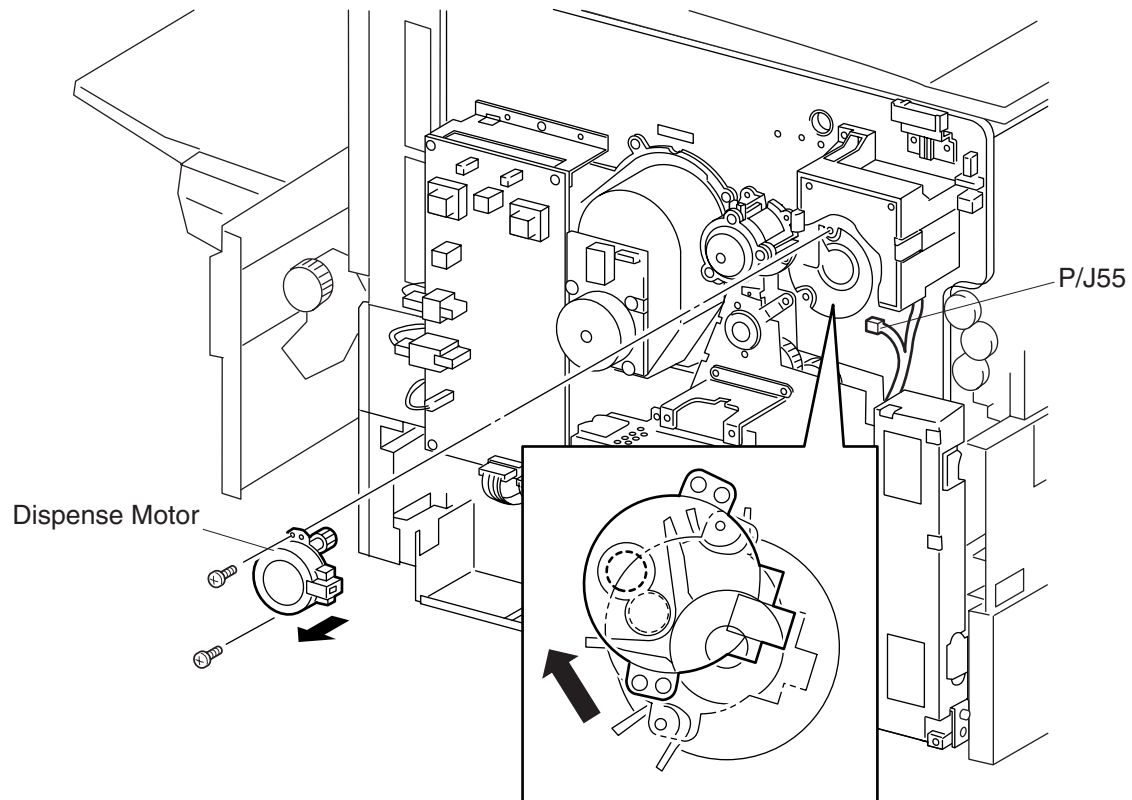
RRP 9.116 Dispense Motor Assembly (PL11.1.22)

1. Reconnect P/J 55 to the Dispense Motor.
2. Position the Dispense Motor so the P/J connector is facing to the right.
3. Reinstall the Dispense Motor by inserting the Motor shaft gear into the large key slot then sliding the Motor down so the shaft rests in the large key slot (inset).
4. Line up the two screw holes in the Motor with the two screw holes in the printer frame.
5. Use two screws to secure the Motor to the frame.
6. Reinstall the Rotary Motor PWB (RRP 9.115).

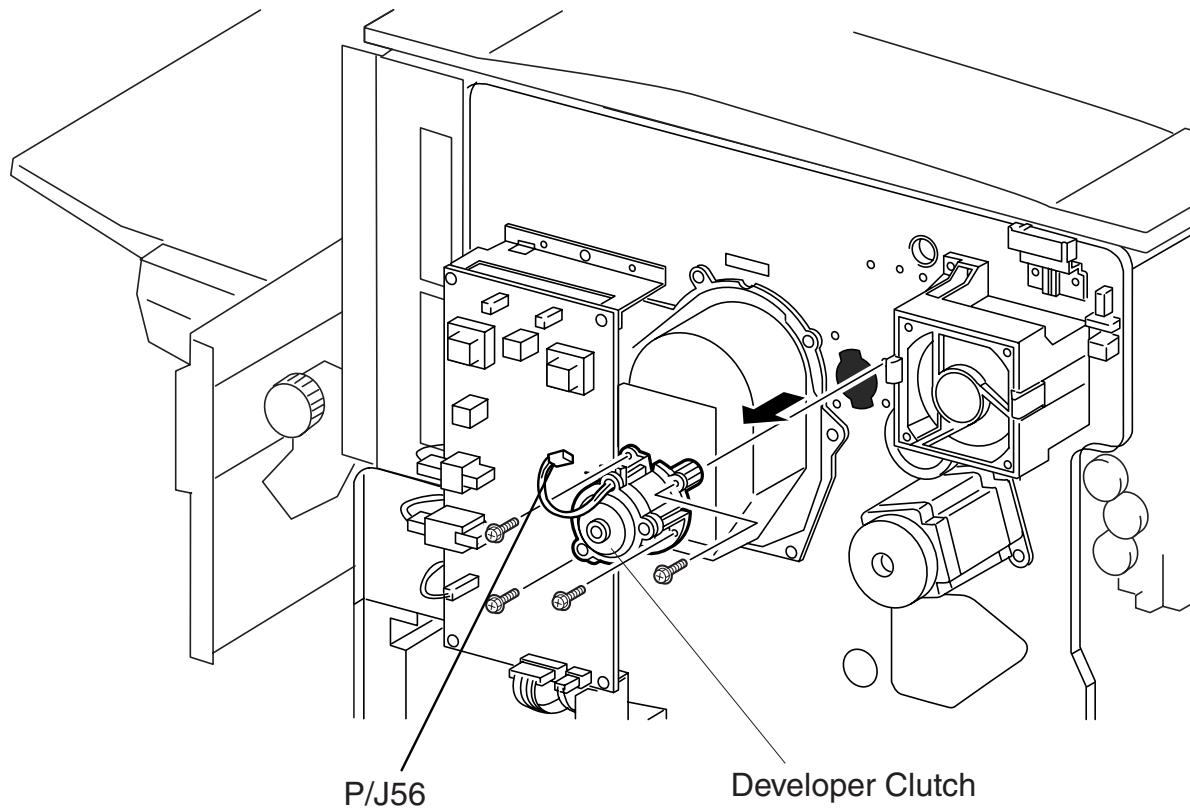
RRP 9.117 Developer Clutch Assembly (PL11.1.23)

1. Position the Developer Clutch Assembly so the wires are at the top of the Clutch.
2. Align the positioning keys on the Clutch with the cutouts in the frame and press the Clutch against the frame.
3. Line up the four screw holes in the Clutch with the four screw holes in the frame.
4. Use four screws to secure the Developer Clutch Assembly to the printer frame.
5. Reinstall the Fuser Drive Assembly (RRP 9.110).
6. Reconnect P/J 56 to the Developer Clutch.
7. Reinstall the Rotary Motor PWB (RRP 9.115).

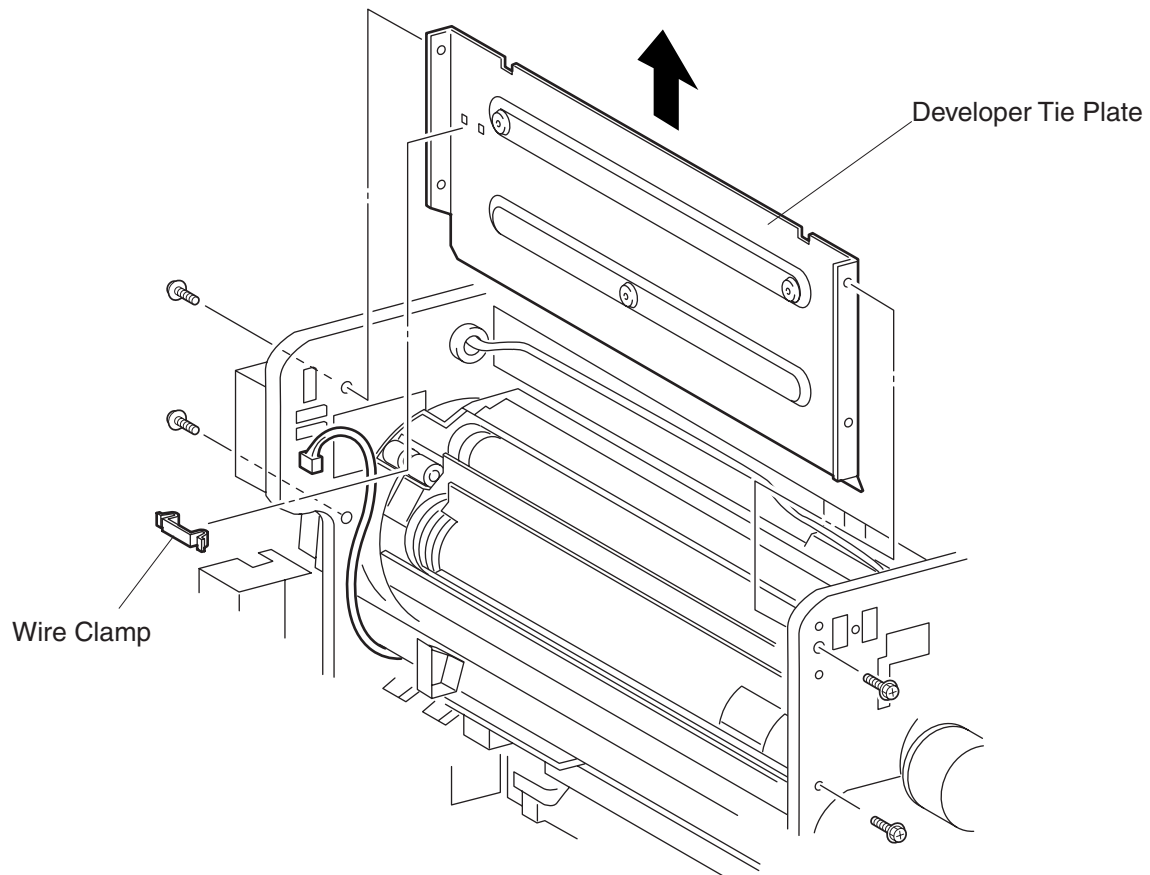
RRP 9.118 Developer Tie Plate (PL12.1.4)

1. Position the Developer Tie Plate as shown.
2. Slide the Tie Plate down into position, behind the P/J connectors that are located on the rear of the printer frame.
3. Use two screws to secure the Developer Tie Plate to the front of the printer frame.
4. Use two screws to secure the Developer Tie Plate to the rear of the printer frame.
5. Reinstall the Wire Clamp and wire onto the Developer Tie Plate.
6. Reinstall the Inner Cover (RRP 9.2).
7. Reinstall the Rear Cover (RRP 9.4).
8. Reinstall the Lower Exit Assembly (RRP 9.101).

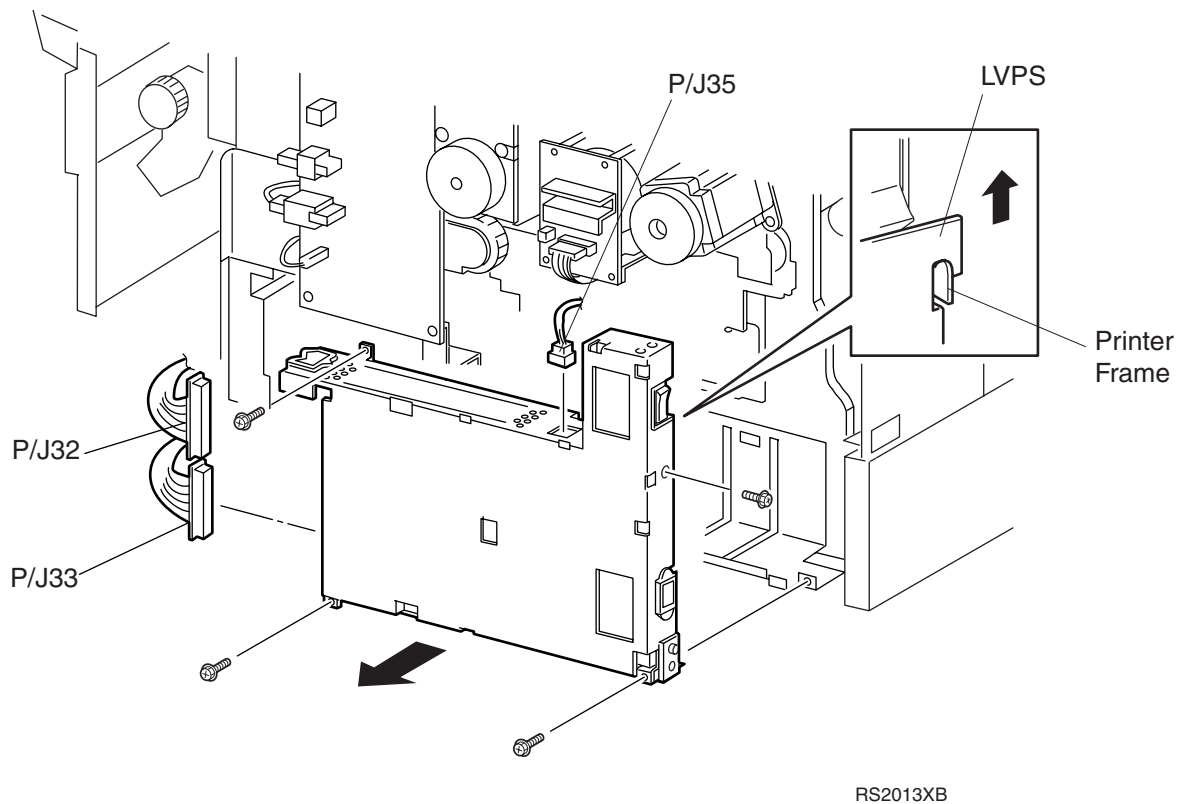
RRP 9.119 Low Voltage Power Supply (LVPS) (PL13.1.1)

1. Move the wire harnesses out of the way and reinstall the LVPS onto the printer frame making sure you hook the rear of the LVPS over the tab on the printer frame (see inset).
2. Line up the four screw holes in the LVPS with the four screw holes in the printer frame.
3. Use four screws to secure the LVPS to the printer frame.
4. Reconnect P/J 32 and P/J 33 to the LVPS.
The plug snaps into place.
5. Reconnect P/J 35 to the top of the LVPS.
The plugs snap into place.
6. Reinstall the Rear Cover (RRP 9.4).

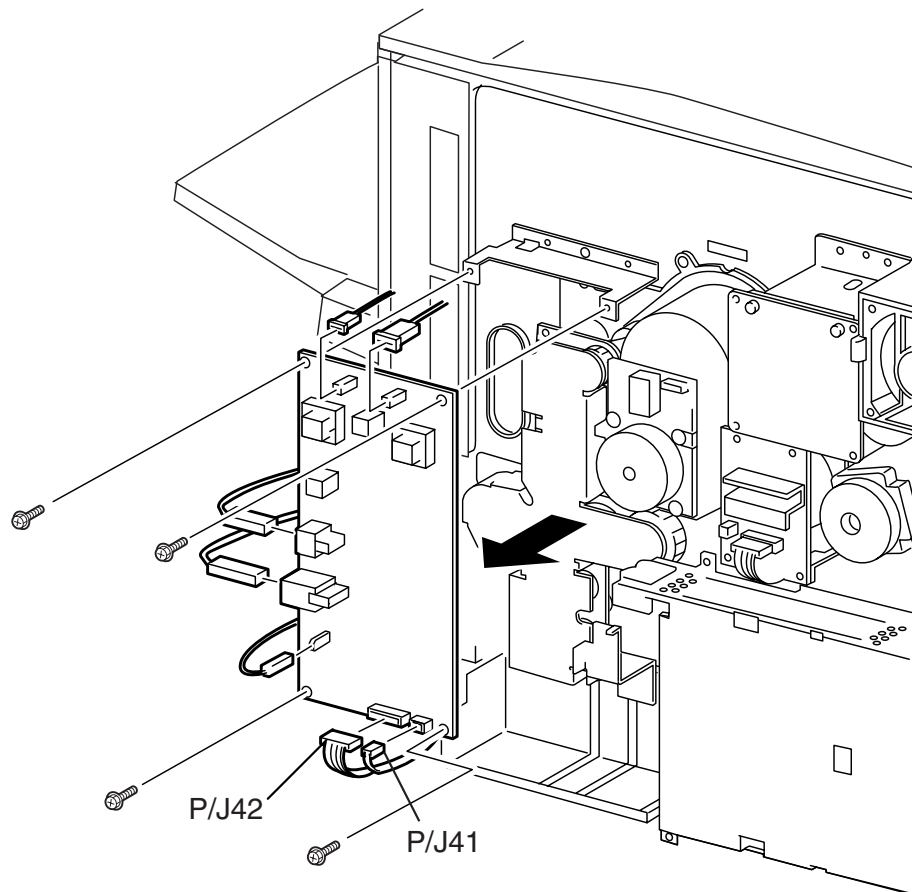
RRP 9.120 High Voltage Power Supply (HVPS) (PL13.1.2)

1. Position the HVPS so xerographic connections A and C are at the top of the PWB.
2. Reinstall the HVPS onto the HVPS Brackets, making sure that none of the wire harnesses are trapped between the HVPS and the printer frame.
3. Use four screws to secure the HVPS to Brackets.
4. Reconnect the five xerographic voltage P/Js to the HVPS.
5. Reconnect P/J 41 and P/J 42 to the bottom of the HVPS.
6. Reinstall the Rear Cover (RRP 9.4).
